Manhole Inspection Summary

Manhole # S21C__033MH

Location Address: **527 FULTON-ALLEY-MOUNT** Cross Street: **FRANKLIN ST**

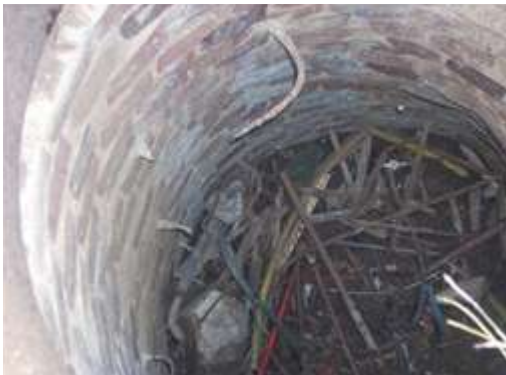
Defect 3

Steps Count: **1** Missing: **3** ☒ **Corroded**

CORRODED AND MISSING STEPS

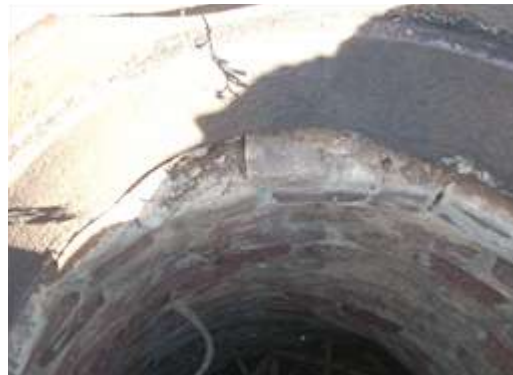
Defect 2

Frame Offset: **2** (in.) Condition: ☒ Sound ☐ Cracked ☐ Leaks

FRAME OFFSET

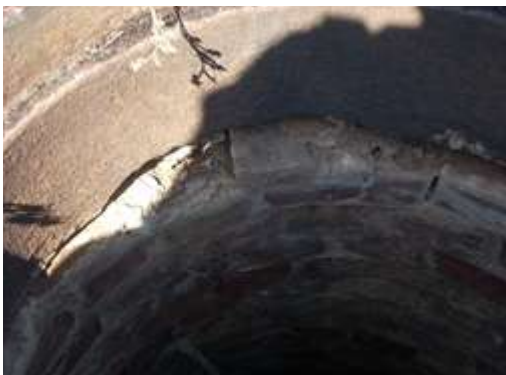
Defect 1

Corbel Material: **Brick** ☐ Parged Type: **Concentric/Eccentric**
Condition: ☐ Sound ☐ Cracked ☐ Root Intrusion ☐ Loose Brick ☒ **Deteriorated**
Infiltration: ☒ None ☐ Joint ☐ Cracks ☐ Mortar ☐ Roots ☐ Wall

CORBEL DETERIORATION

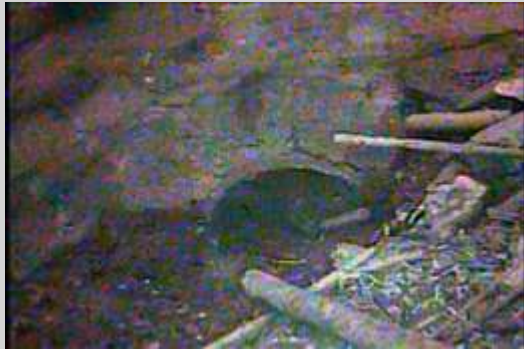
12 O'Clock Outflow

8 in. Circular Gravity Sewer
Pipe Out @ 12 O'Clock

Deposits: ☐ None ☐ Mud ☐ Sludge ☒ **Debris** ☐ Grease

Silt Depth: **2** (in.) Deposits Extent: **Medium**
